PHASE II ARCHAEOLOGICAL AND GEOMORPHOLOGICAL INVESTIGATIONS AT THE PROPOSED GREENBELT PROJECT, DES MOINES, IOWA

CULTURAL RESOURCES MANAGEMENT
REPORT NO. 156

SEPTEMBER 1991

Phase II Archaeological and
Geomorphological Investigations
for the proposed Plaza/Amphitheater
Des Moines Recreational River and Greenbelt
Des Moines, Iowa

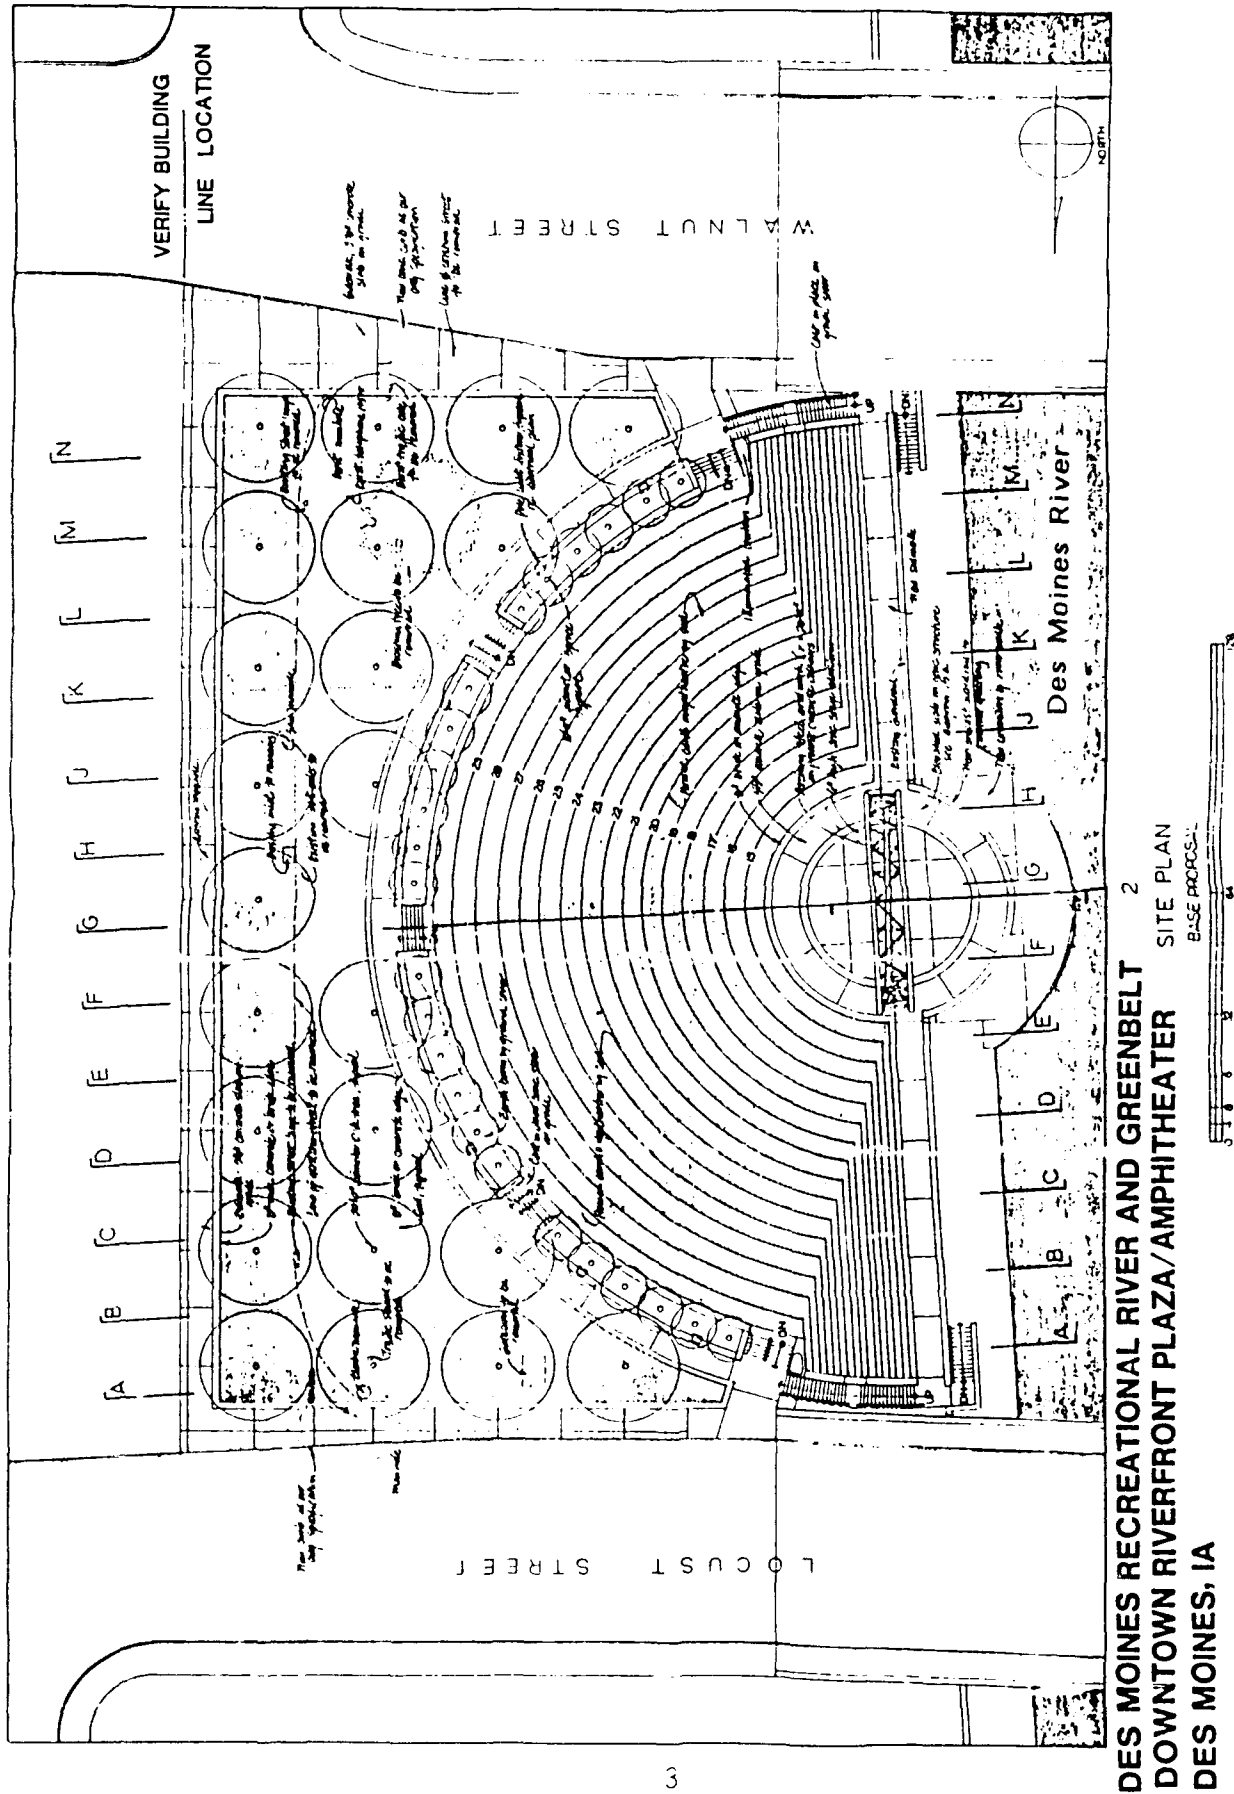
Figure 2. Impact of project construction.

Impacts to the area include : the construction of a low profile landscape plaza and amphitheater (Figure 2), the construction of a metal arc mast for lighting and sound attachment; and the construction of a stage penetrating the Des Moines Riverwall and extending into the river channel. These impacts extend into the National Register of Historic Places (NRHP) Civic Center Historic District within the city of Des Moines.

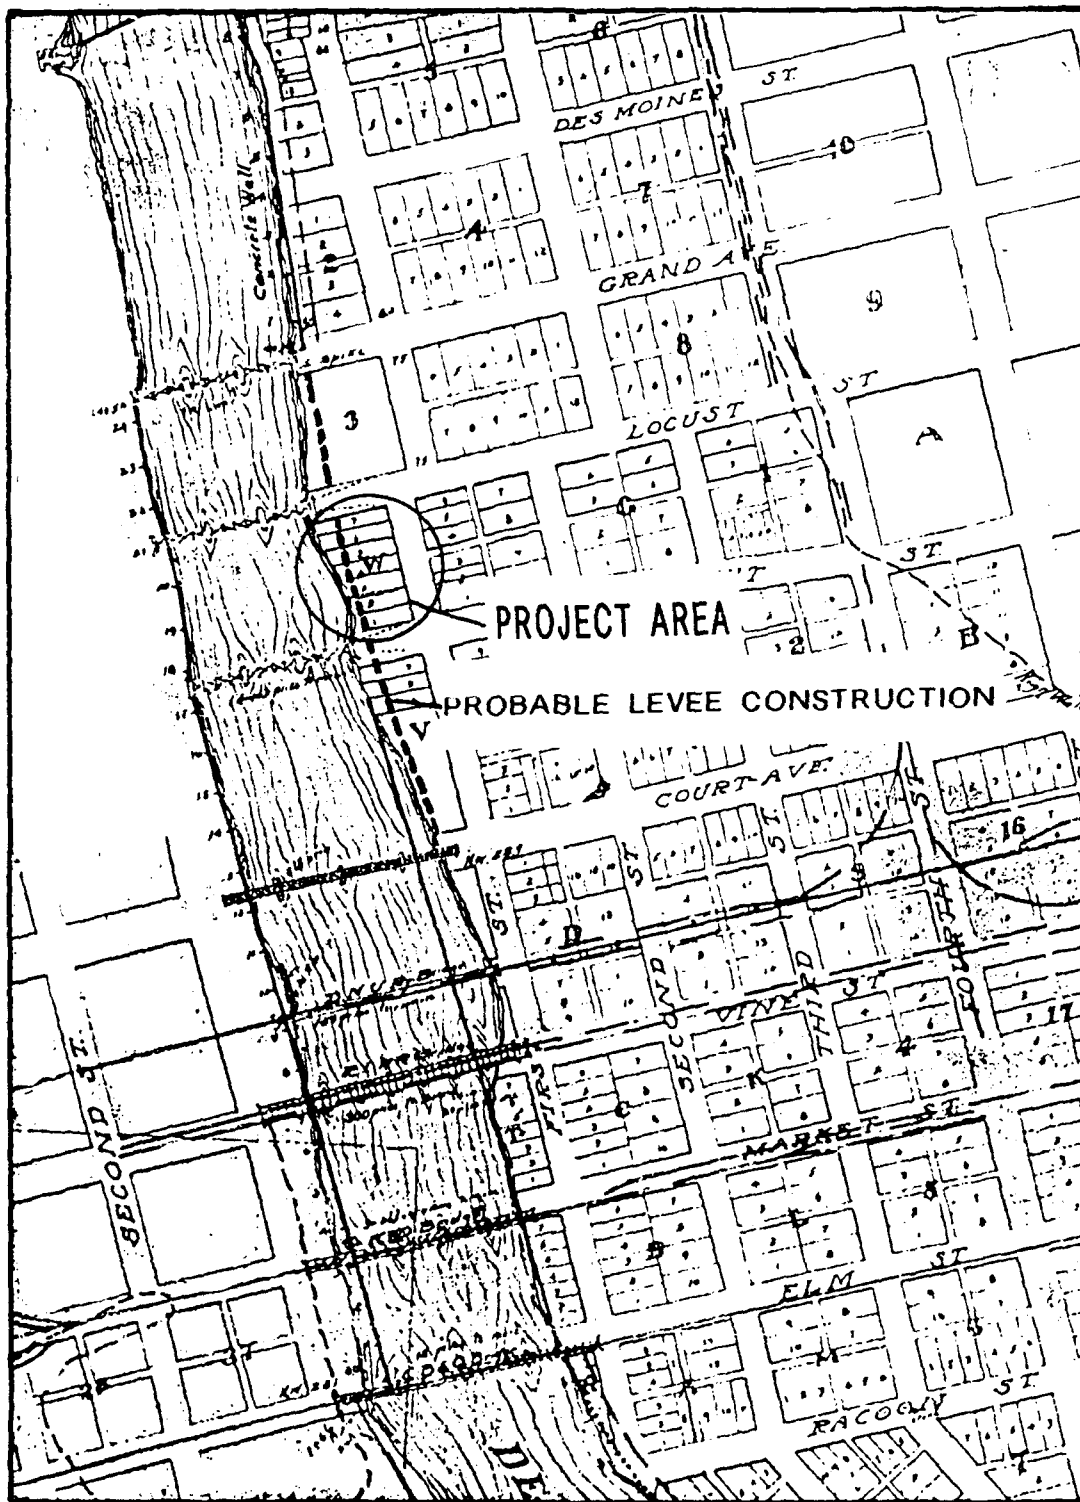
Figure 8. Project area located on 1907 Des Moines River Improvement map detailing the location of levees and excavations (City Engineers Office 1907).

A 1907 map of the city of Des Moines documents the project area devoid of structures and with a probable levee running through it (Figure 8). The structures occupying the project area in 1901 must have been razed before 1907, and may have been used in the construction of the levee. By 1910 the area was known as East Riverside Park (Figure 9) and was completely vacant by 1920 (Figure 10).

At the west end of both trenches A and B, and resting on river bank sands were similar piles of stone and brick rubble (Figure 20). This location and alignment of these deposits suggest the use of building stone and brick to create a crude rip-rap levee, and it may have been noted on an early city map (Figure 8).

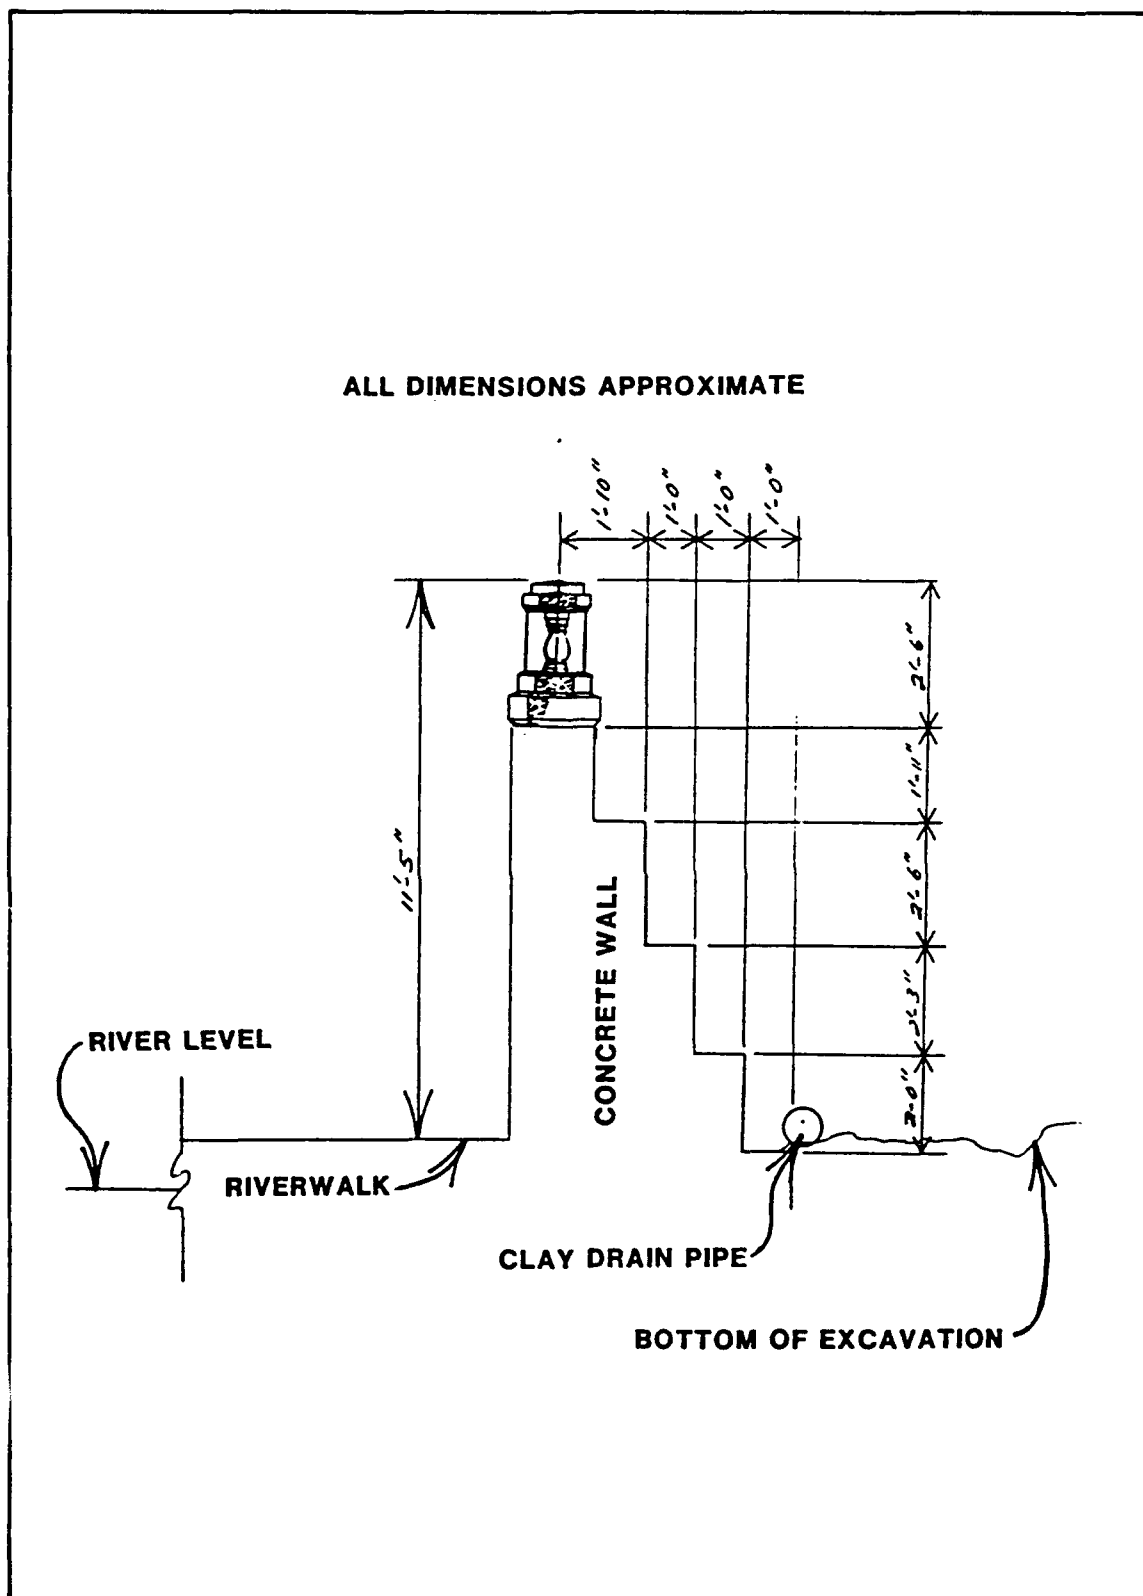
Figure 14. Cross-section of riverwall construction.

The lower portion of the riverwall was constructed between 1910 and 1925 as the above photographs in Figures 11 and 12 indicate. The upper portion of the riverwall and balustrade were not constructed until the late 1920s or early 1930s. A cross section of the existing riverwall, which is a composite of the lower and upper walls mentioned above, demonstrates the degree of impact this structure has had on the project area through both excavation and redeposited fill (Figure 14).

The concrete wall extends 8 ft. 8 in. from the base of the wall to the base of the balustrade (Figure 14). The balustrade extends an additional 2 ft. 6 in.. The wall extends a minimum of 12 1/2 ft. from the river's edge, indicating the original nineteenth century ground surface was disturbed during construction. In addition, fill must have been placed on the original ground surface behind (east) of the riverwall.

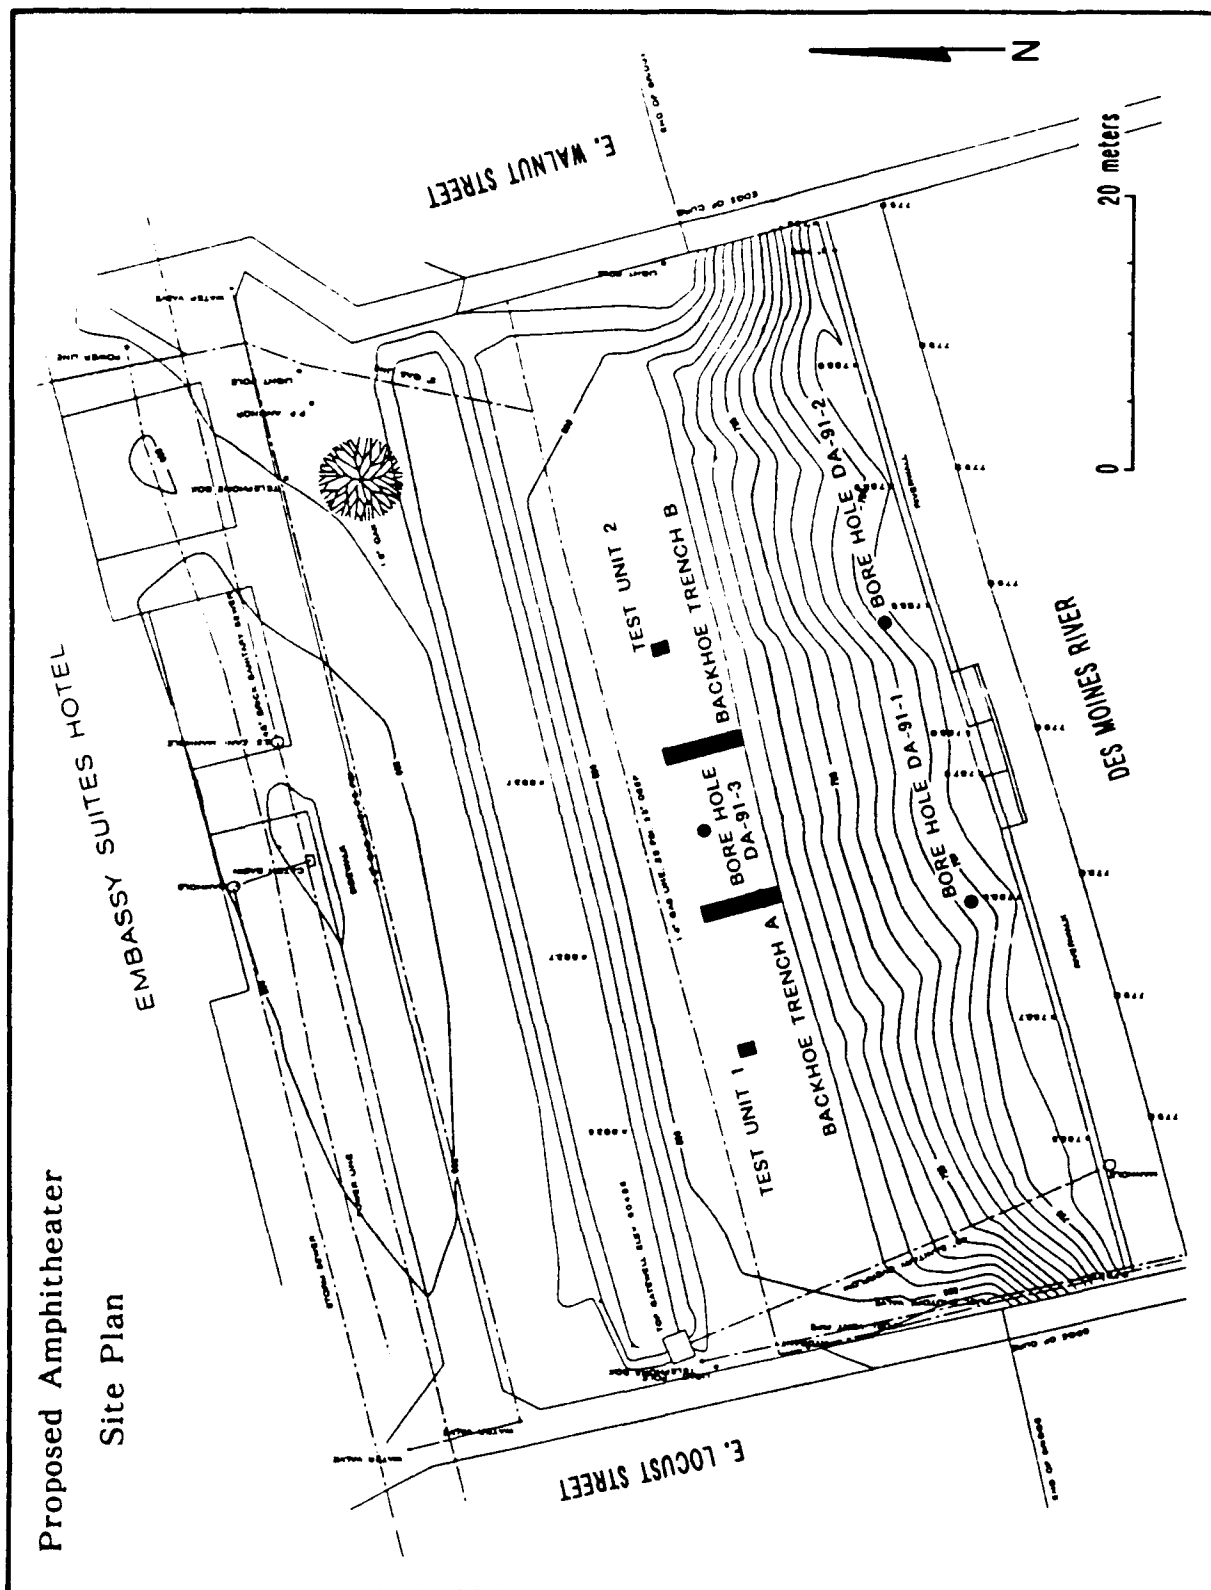
Figure 15. Planview of project area showing past impacts and the location of test units, backhoe trenches, and core samples.

within the area of late 19th century commercial and residential development. While the excavation of a storm water line damaged the north end of the project area (Figure 15), no additional impacts have been noted in the last 15 years (Jim Grant 1991).

Backhoe Trench A was located 10 meters south of test unit 1 and excavated perpendicular to the river at an approximate length of 6 meters and depth of 2.5 meters (Figure 15). The profile exhibited highly disturbed soils indicative of previous excavation and fill. Cinders,

Backhoe trench B was located 10 meters south of backhoe trench A and 10 meters north of test unit 2 (Figure 15). This trench was excavated to an approximate depth of 2.5 meters and was approximately 5 meters long. The profile was similar to that of trench A in terms of soil content, artifact density, and degree of disturbance (Figure 20 and 21). Diagnostic artifacts, which include ceramic, glass, metal, and brick, were recovered from the backdirt pile.

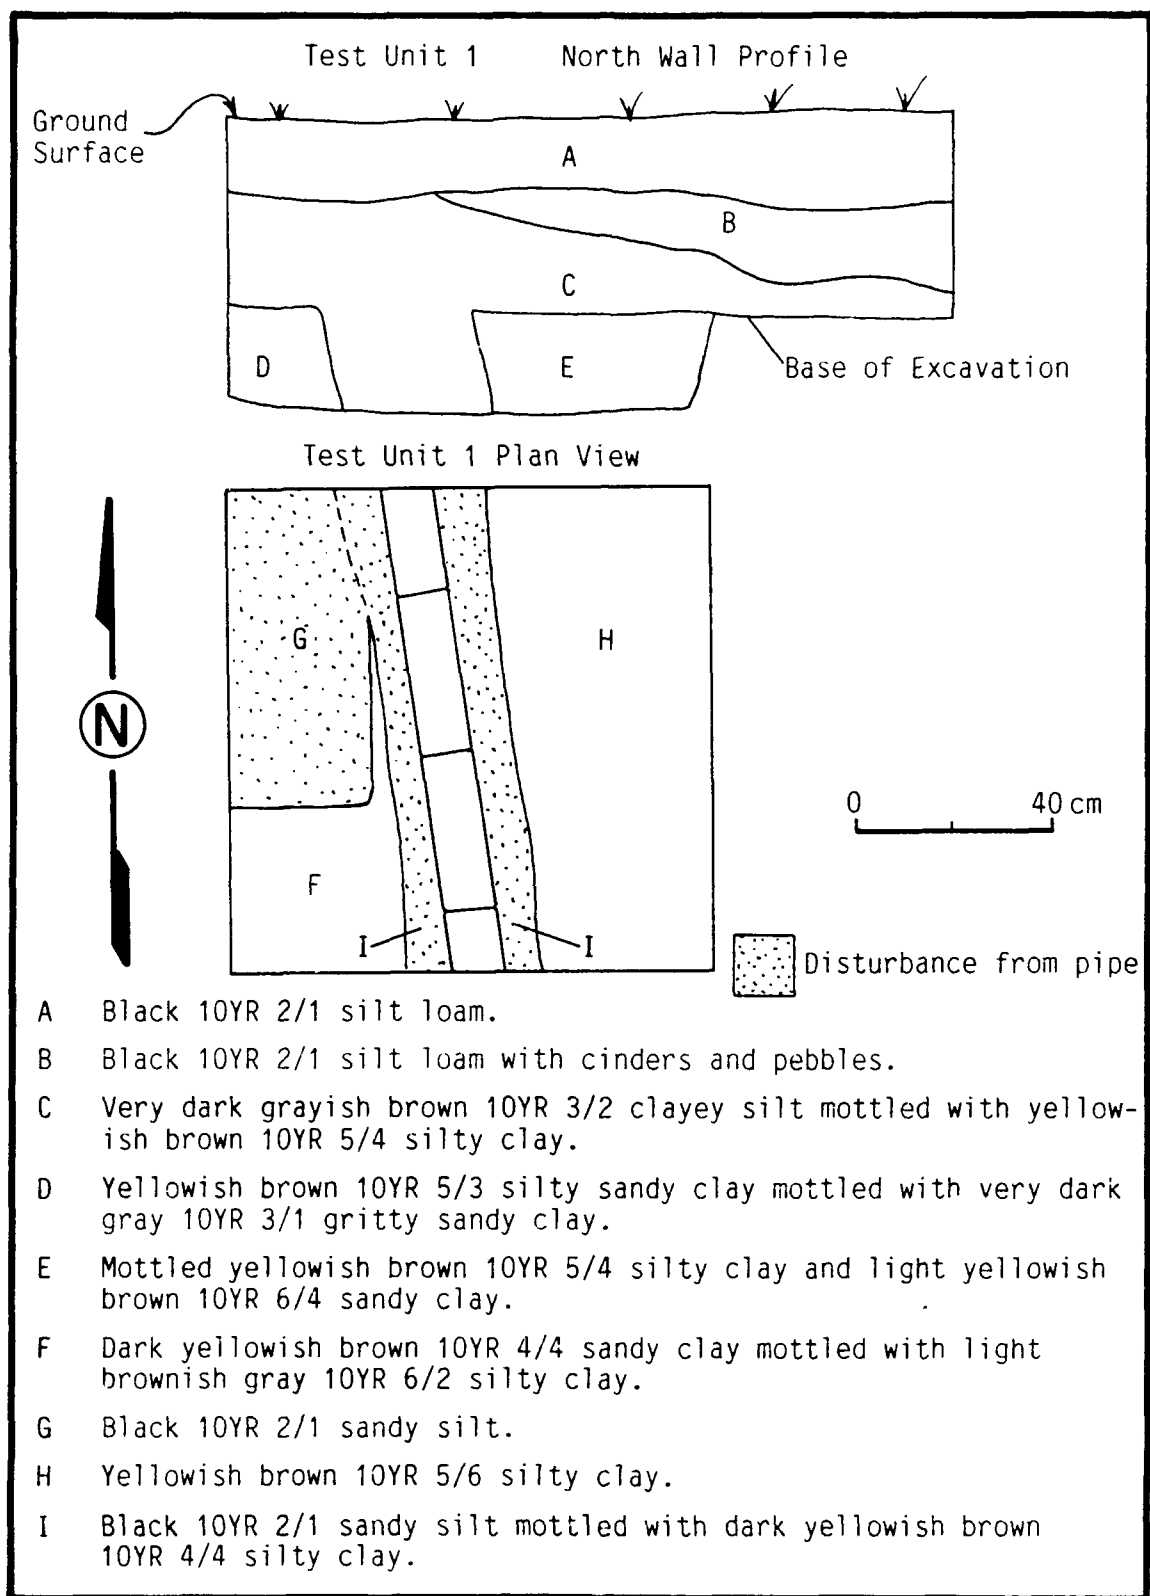
Figure 17. Plan view and profile, test unit 1.

Test unit 1 was excavated to a depth of 60 cm BS and documented a highly disturbed soil profile consisting of black 10YR 2/1 silt loam overlying highly mottled clayey silt and silty clay horizons (Figure 17). At 40 cm BS a black 10YR 2/1 stain was noted in the northwest corner of the test unit. Upon completion of level 3, 40 - 60 cm BS, a sewer drain tile extending north/south with an associated soil disturbance was noted. This was documented both in planview and profile (Figure 17 and 18a).

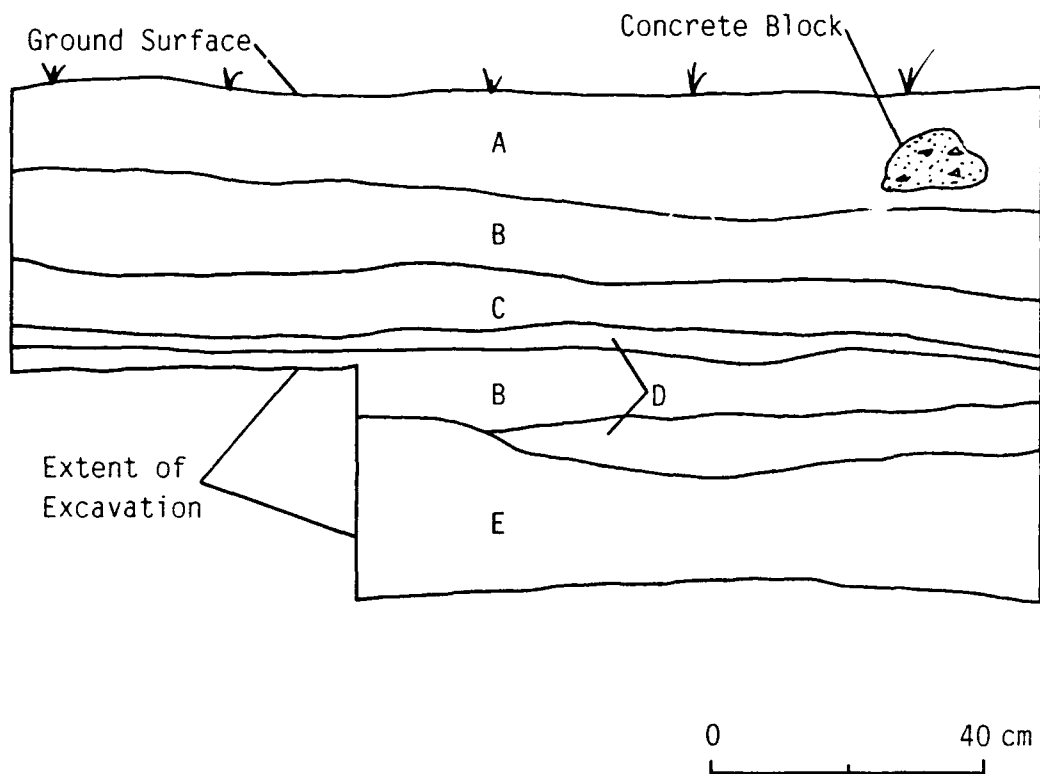
Figure 19. Profile, test unit 2.

Des Moines Amphitheater
Test Unit 2
North Profile

- A Very dark brown 10YR 2/2 silt loam with yellowish brown 10YR5/4 mottles
- B Dark grayish brown 10YR 3/2 silt loam
- C Very dark brown 10YR 2/2 sandy silt
- D Very dark brown 10YR 2/2 sandy silt with gravel
- E Yellowish brown 10YR 5/6 silty sand

Numerous very small gravels and cinders in all levels.
Soils are highly disturbed.

Test unit 2 was located 30 m south of test unit 1 and excavated to a depth of 70 cm BS. The soil profile includes very dark brown and very dark grayish brown silt loams overlying dark brown sandy silts and yellowish brown silty sands (Figure 18b and 19). The soils are highly disturbed and contain historic cultural materials. The density of artifacts was highest in level 2 (20 to 40 cm BS), although cultural materials were recovered from all levels.
